CASE 4- Case of malposed implants

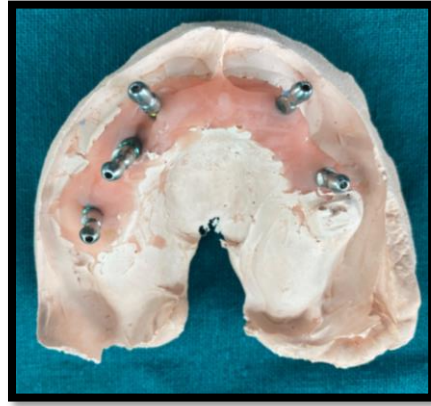
Unfavorable position of implants as seen in the cast which was poured (gum pad used to mimic gingiva)

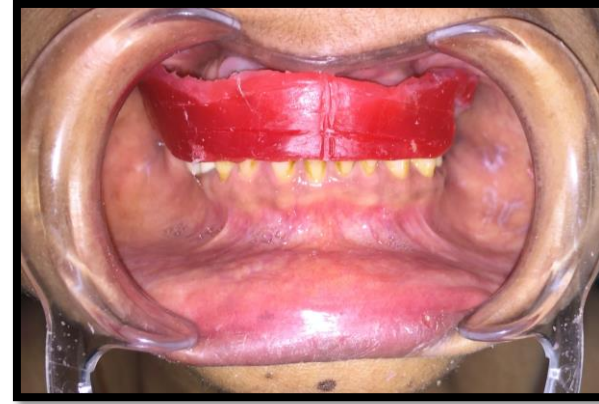
Jaw relation done

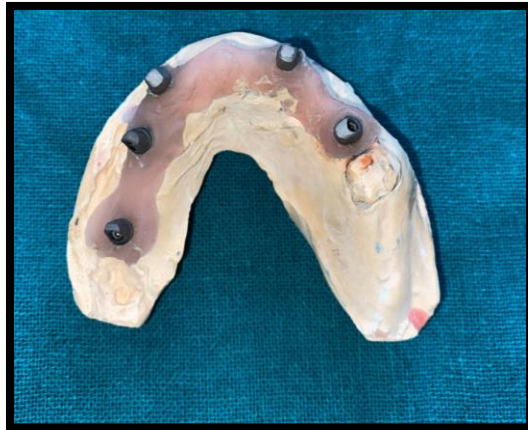
Custom abutments

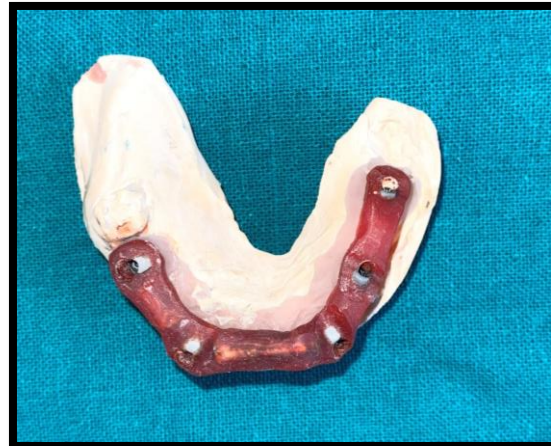
Jig trial (pattern resin)

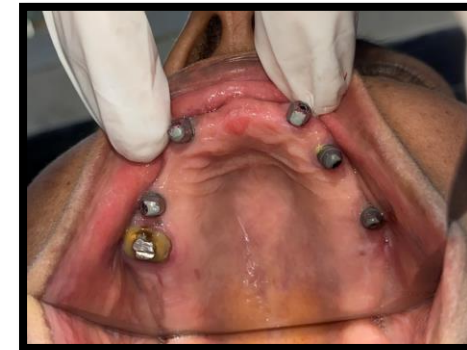
Abutments placed over implants

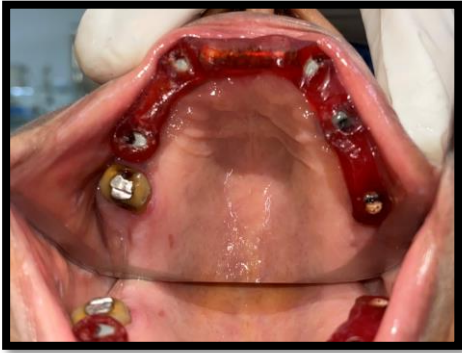
Jig trial verified

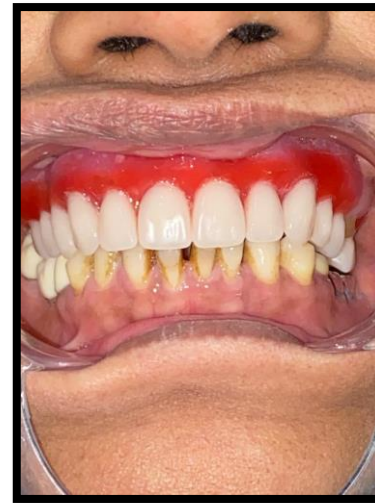
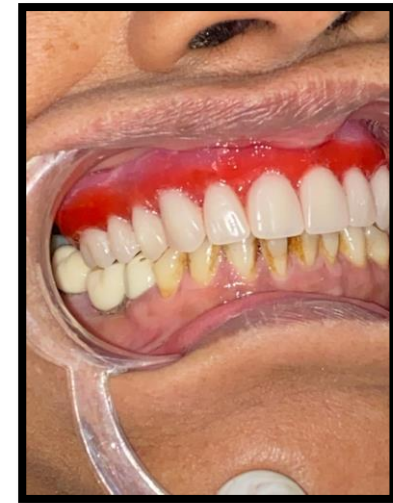
Try in done

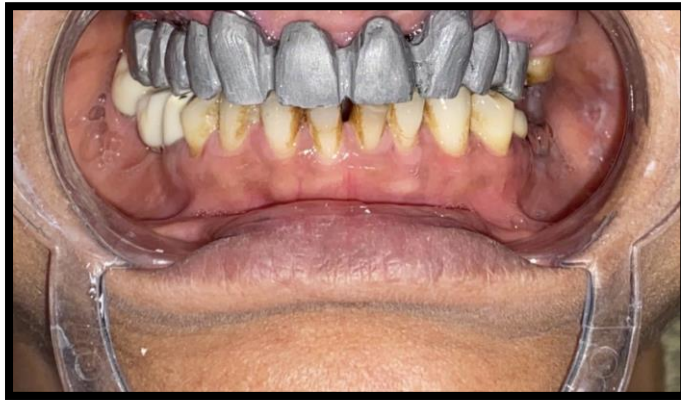
Metal trial

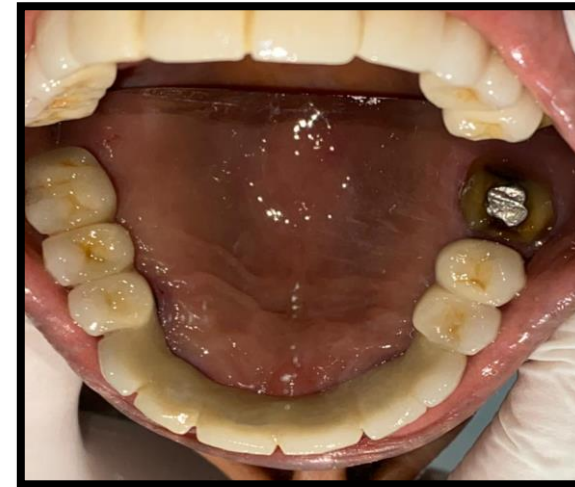
Porcelain fused to metal
framework cemented

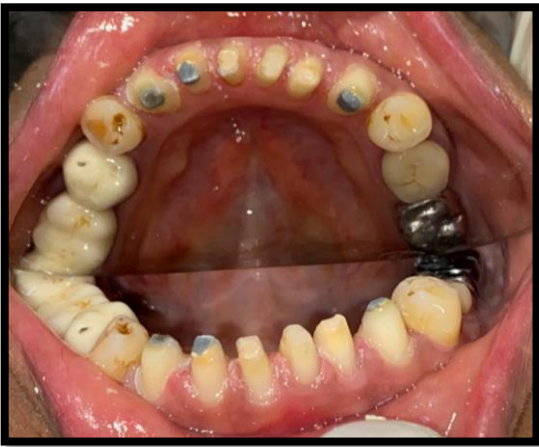
Lower anteriors prepared

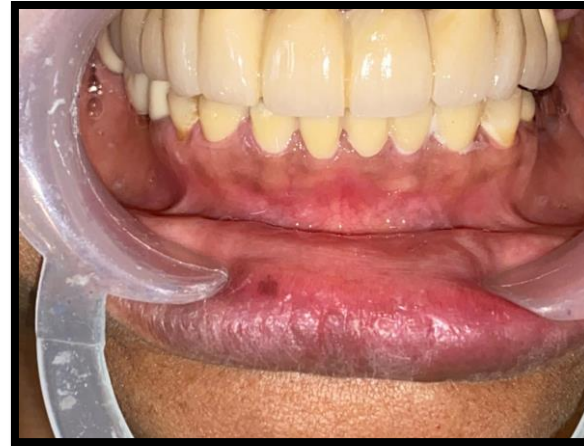
Final upper and lower prosthesis in place
